MOBILE OFFSHORE DRILLING UNIT (MODU) OCEAN RANGER,
O.N. 615641, CAPSIZING AND SINKING IN THE ATLANTIC
OCEAN ON 15 FEBRUARY 1982 WITH MULTIPLE LOSS OF LIFE

1. Report No. USCG 0001 HQS 82		2. Government Accession No. AD-A140 910		3. Recipient's Catalog No.	
4. Title and Subtitle Marine Casualty Report Mobile Offshore Drilling Unit (MODU) OCEAN RANGER, O.N. 615641, Capsizing and Sinking in the Atlantic Ocean on 15 February 1982 with multiple loss of life				5. Report Date 20 May 1983

**REPORT OF THE U.S. COAST GUARD
MARINE BOARD OF INVESTIGATION CONCERNING
THE MODU OCEAN RANGER, O.N. 615641;
CAPSIZING AND SINKING IN THE ATLANTIC OCEAN
ON 15 FEBRUARY 1982 WITH MULTIPLE LOSS OF LIFE**

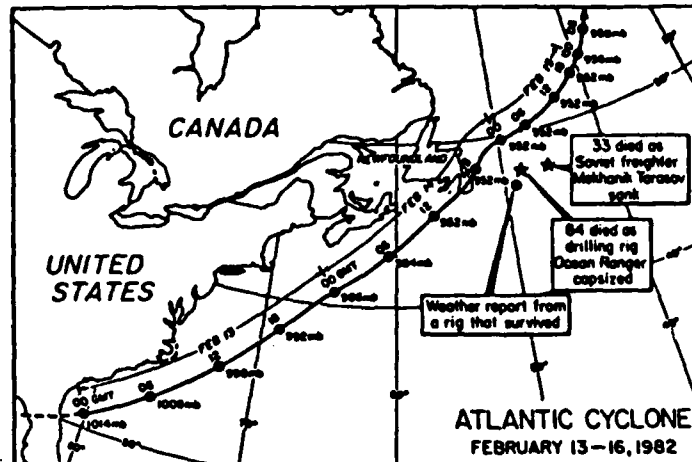
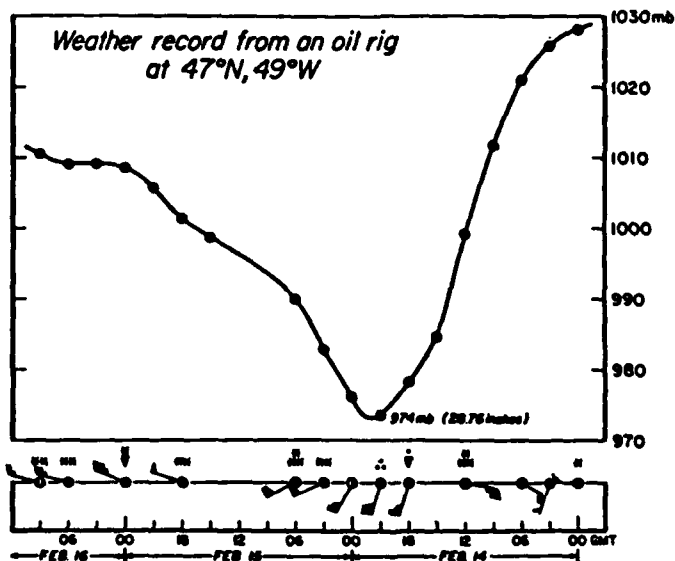
The storm associated with the OCEAN RANGER casualty was a major Atlantic cyclone. Figure 13 shows the storm track and the on-scene weather at the site of the casualty.

Figure 38.—The track of this vicious storm with 6-hr pressures, and the weather record from a nearby oil rig (47°N, 49°W). A total of 117 deaths resulted from this storm. From *Storm Data*, Feb. 1982, prepared by Prof. T.T. Fujita, University of Chicago.

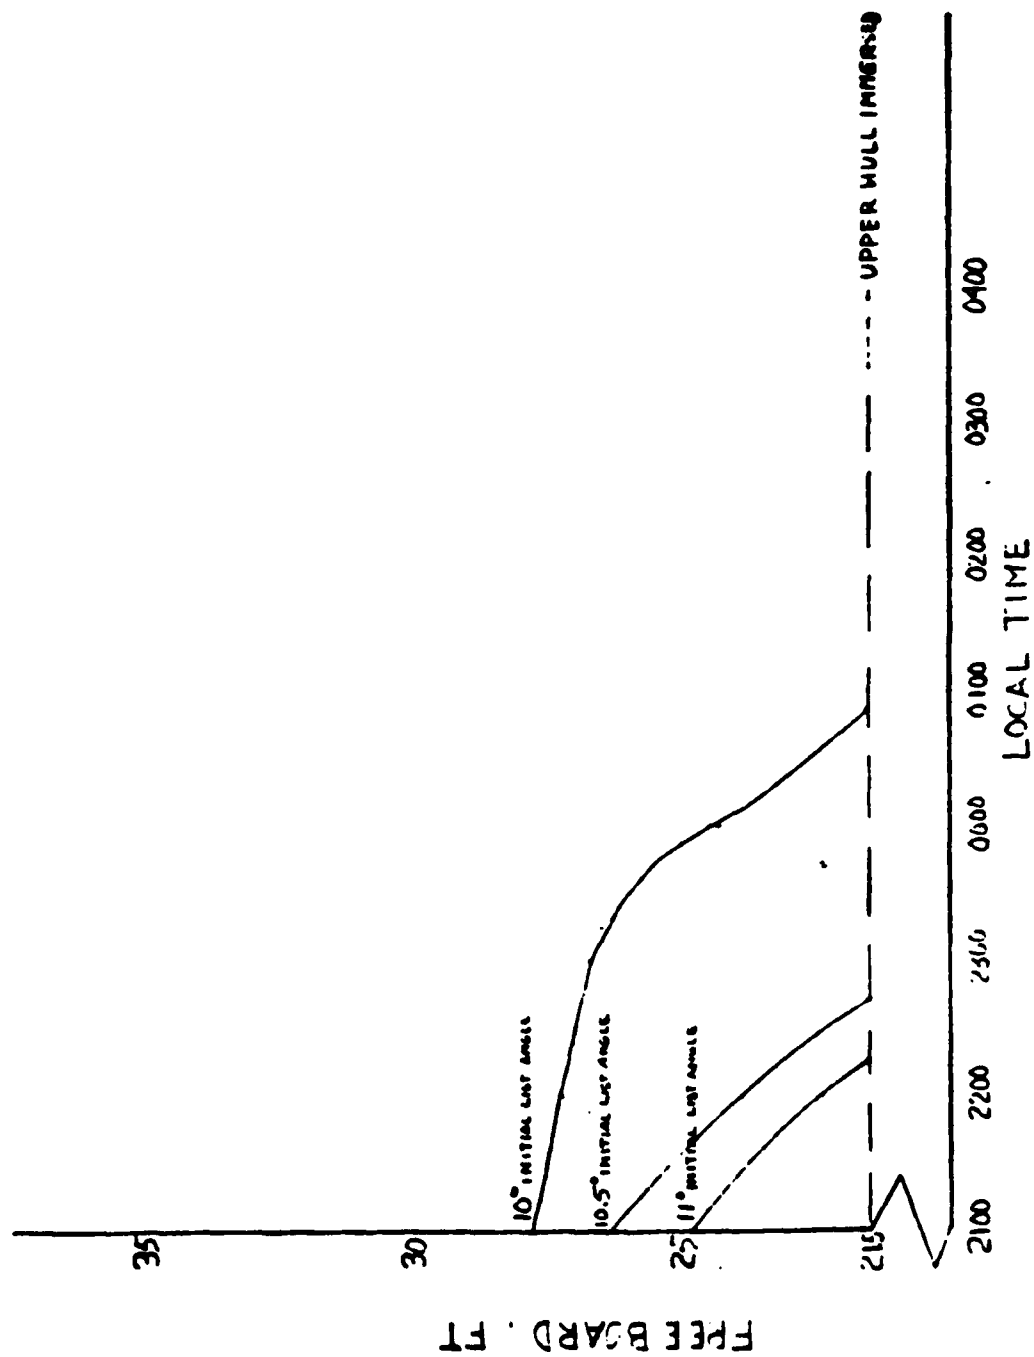
FIG. 9 COMPARISON OF FREEBOARD WITH TIME FOR 90 FEET DRAFT IN A 35- FEET SIGNIFICANT WAVE HEIGHT

Figure 9 is similar to Figures 5 and 7, but with an initial draft of 90 feet.

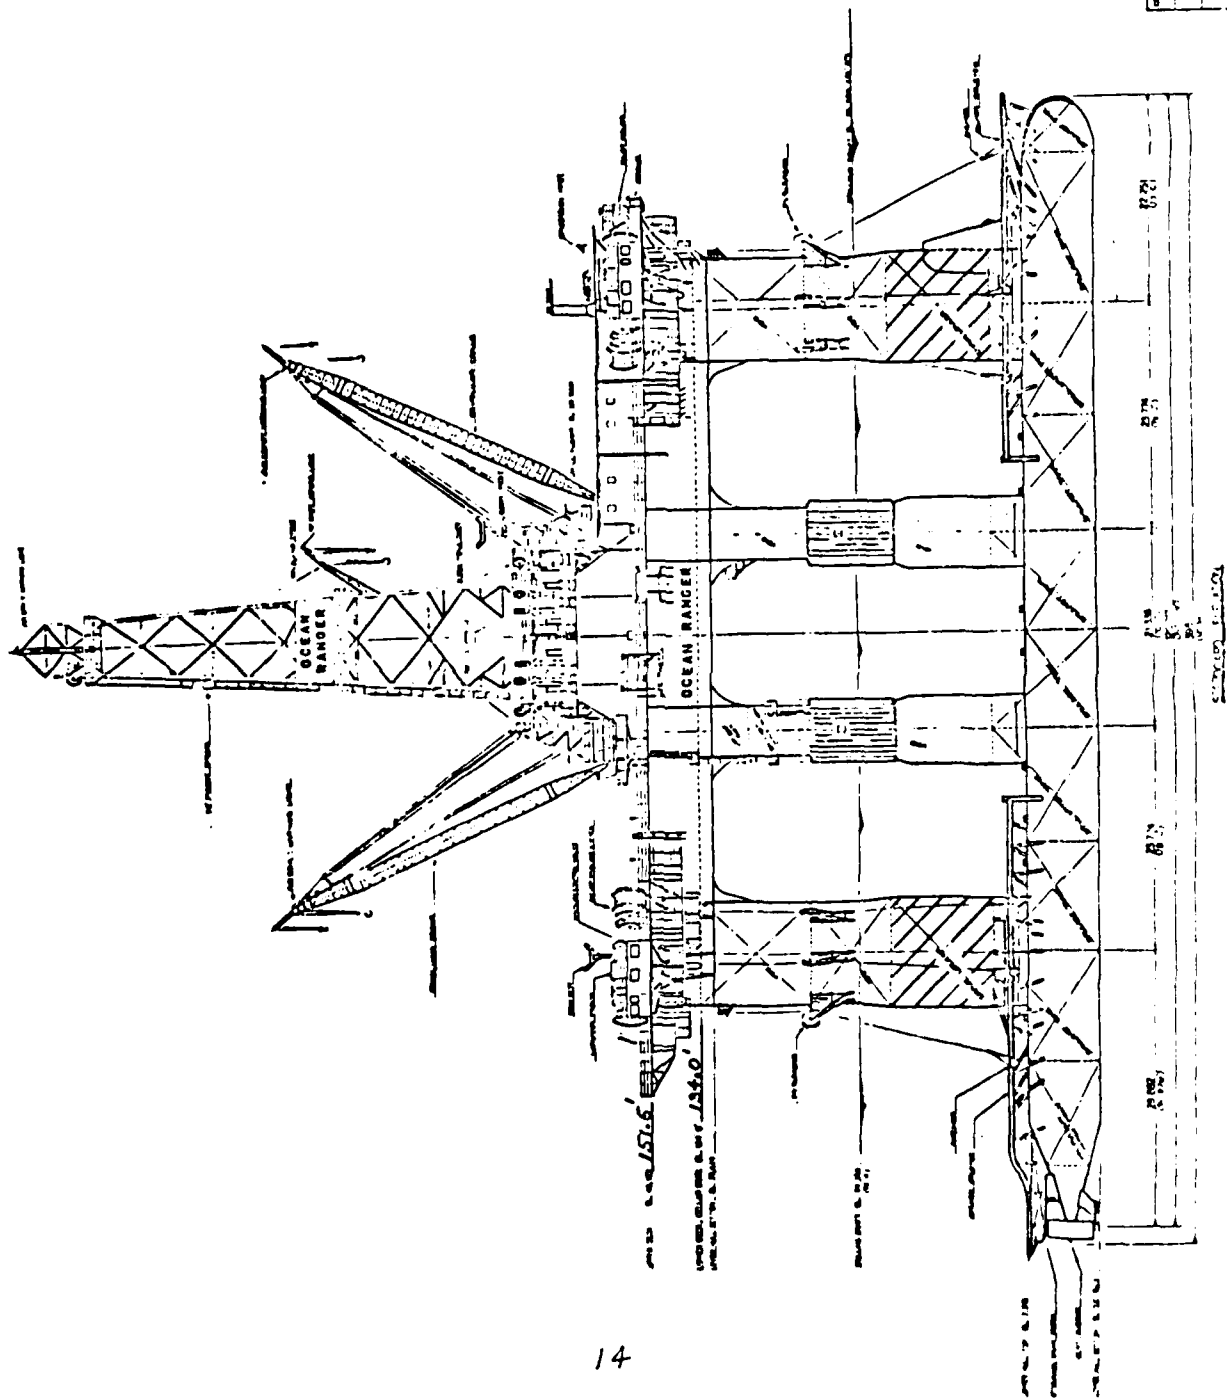
Figure 1 - Profile View of OCEAN RANGER

The OCEAN RANGER was approximately 399 ft. (121.6 m) in overall length at the lower hulls; the overall beam to the outer edges of the lower hulls was about 262 ft. (79.9 m). Figure 1 shows a profile view of the platform, with the chain locker region cross-hatched. Some calculations were done previously by the Office of Merchant Marine Safety, U.S. Coast Guard to determine conditions (eg., static list angle, wave height) for the inception of chain locker flooding, and length of time required to fill the chain locker¹ *. This earlier investigation did not consider the motions of the platform in the seaway. Instead, the OCEAN RANGER was assumed fixed at several drafts and list angles, and various wave crests were positioned on the platform to find the number of green water occurrences. This approach could be improved upon because relative motion between the platform and waves was neglected.

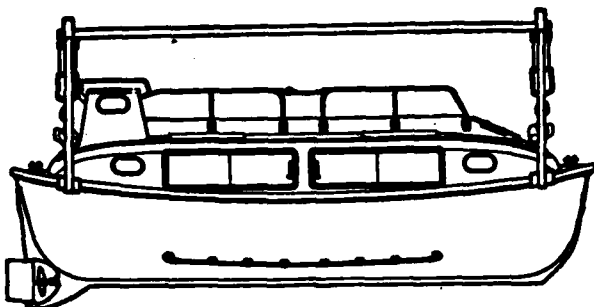
Figure 2a. Harding lifeboat #1 shown in normal stowage position in davit.
